Docket No. SA-537

NATIONAL TRANSPORTATION SAFETY BOARD

Attachment 1 – Photographs

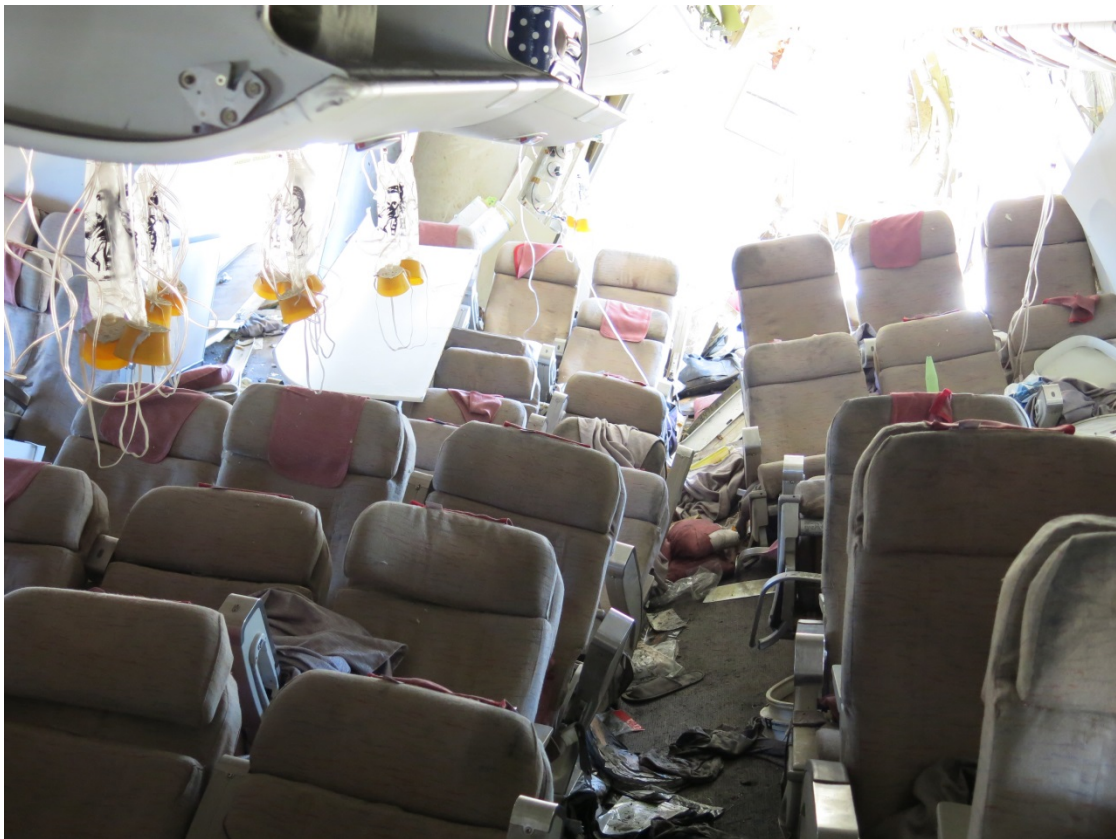
Photo 91. Forward-facing view of C-zone from right aisle near row 40.

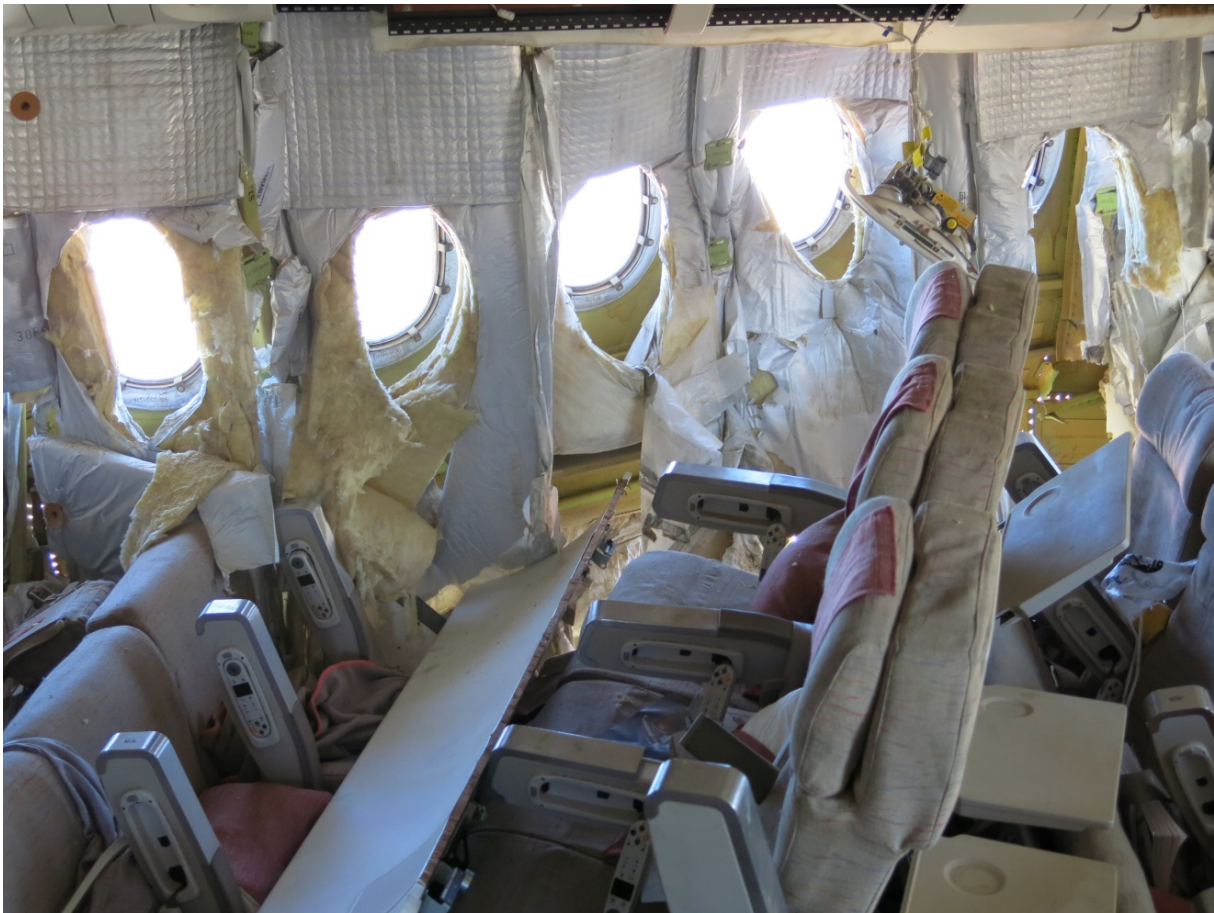
Photo 92. Aft-facing view of C-zone from left aisle near row 36.

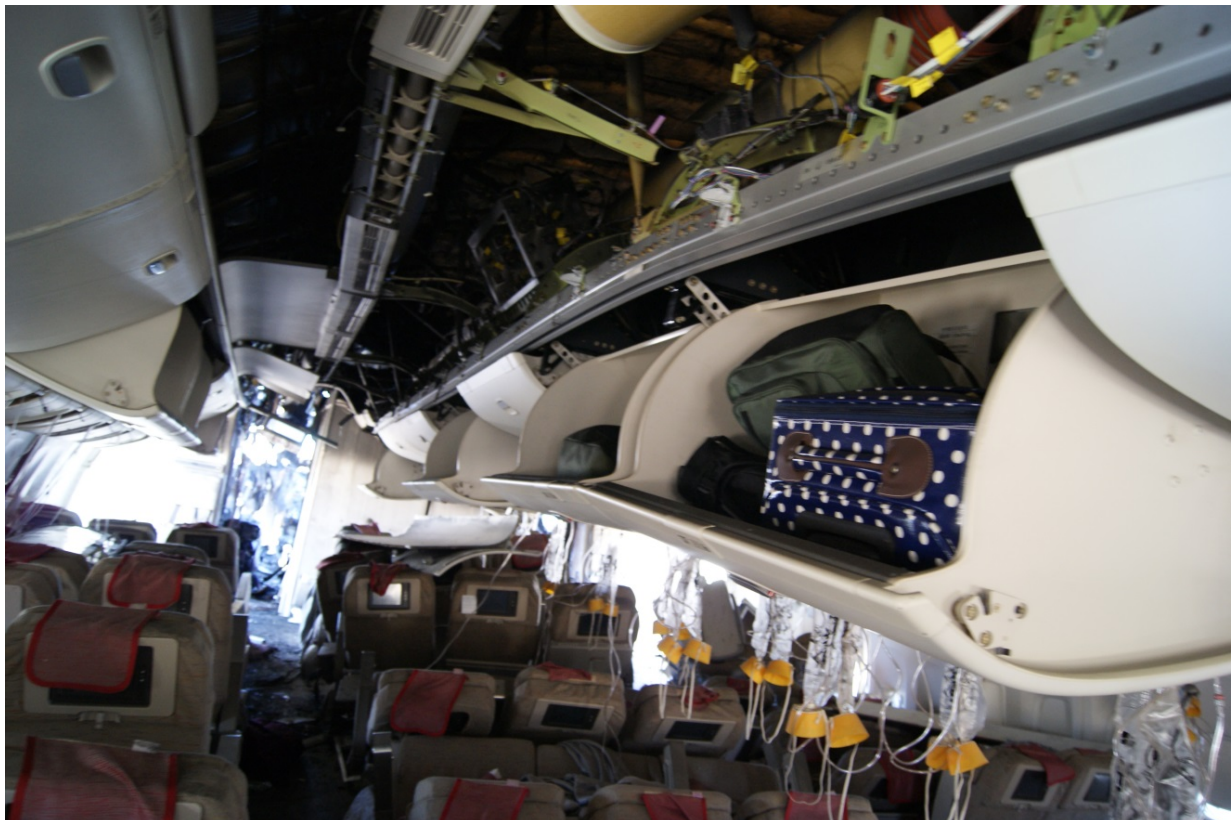
Photo 93. C-zone row of seats aft of the right aisle near row 39.

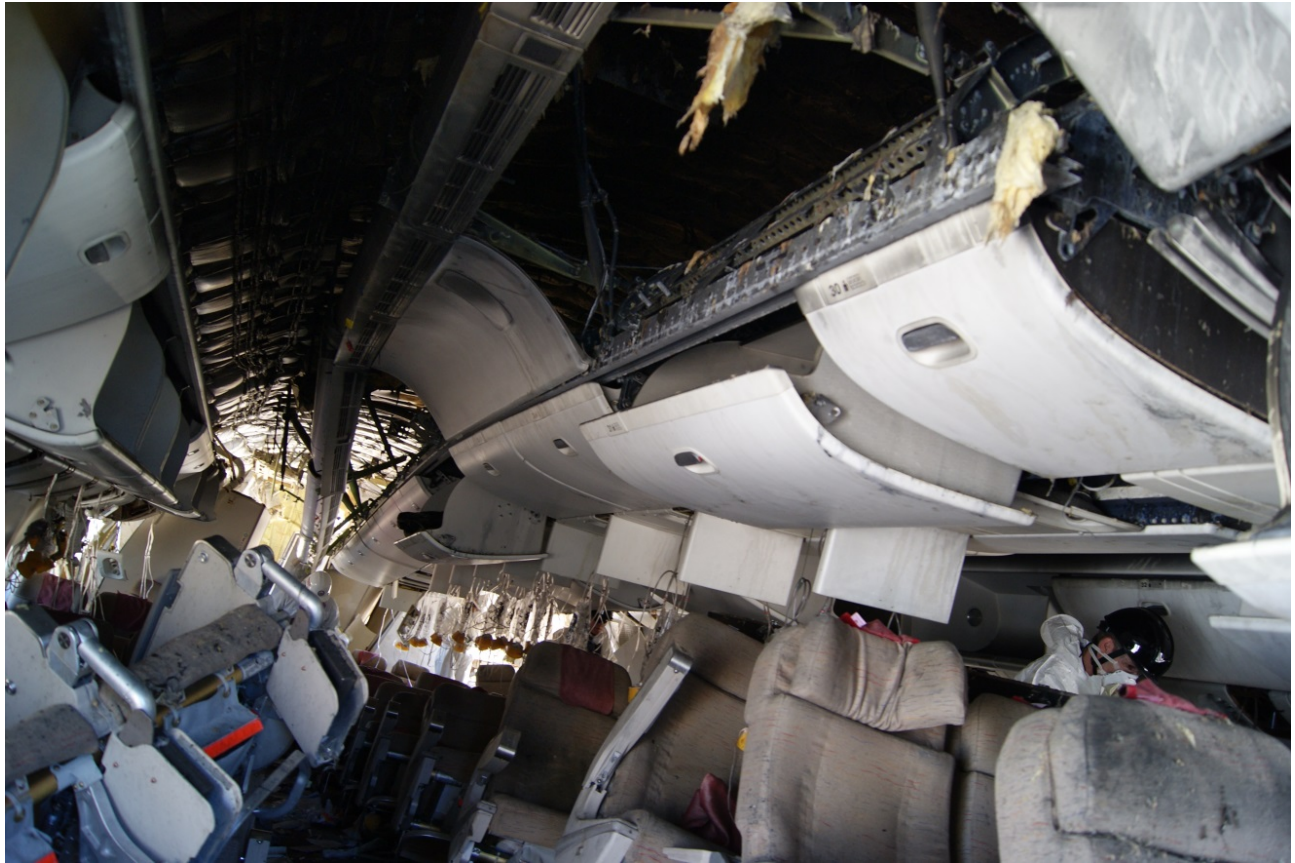
Photo 95. Aft-facing view of C-zone from left aisle near door 3L.

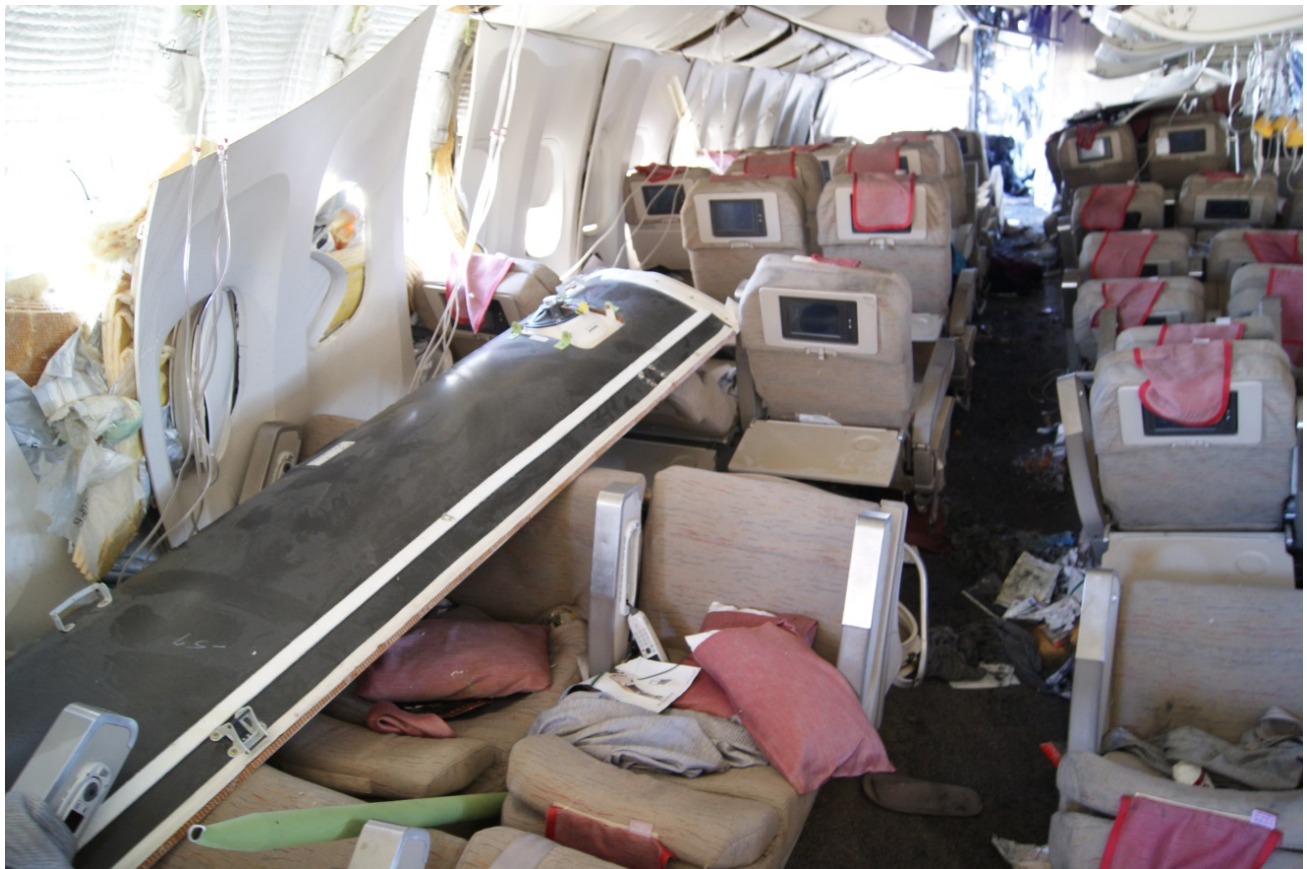
Photo 96. Forward-facing view of C-zone from the left aisle near row 40.

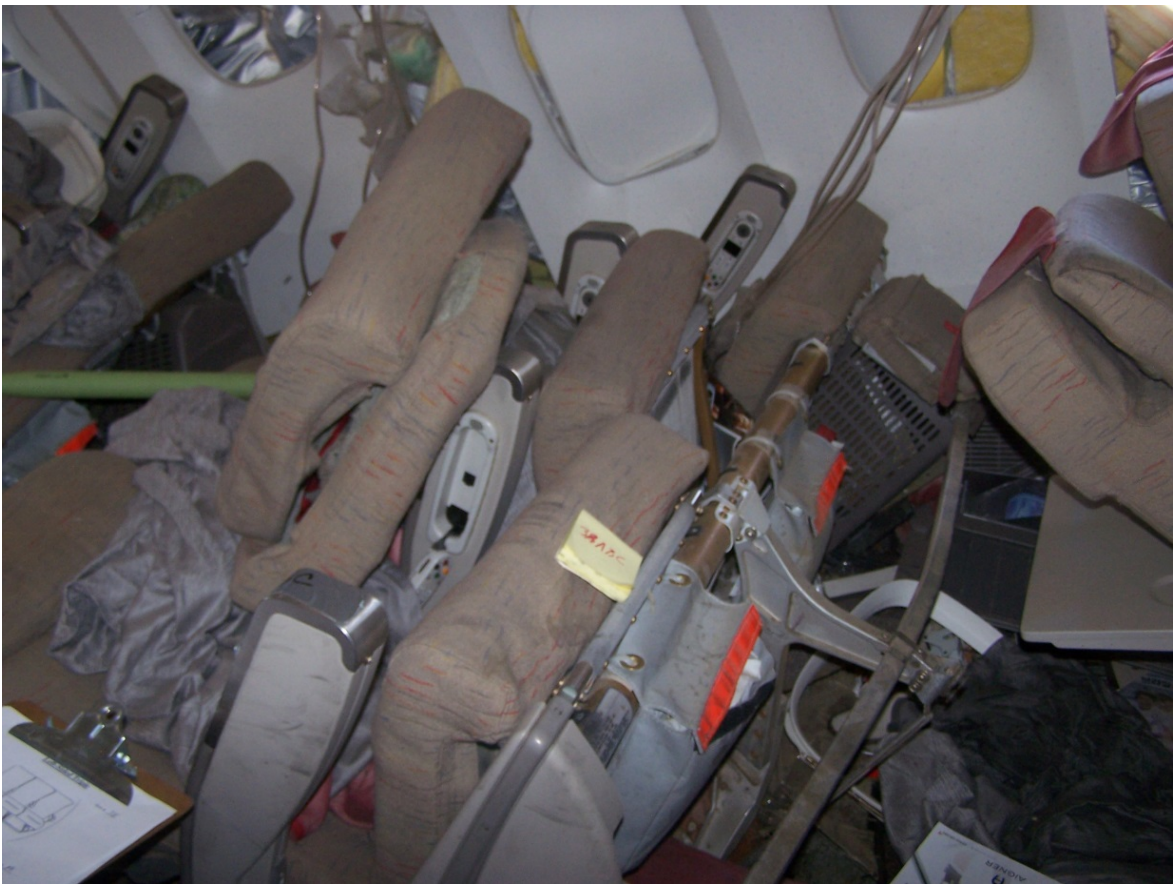
Photo 97. C-zone seats 38 ABC.

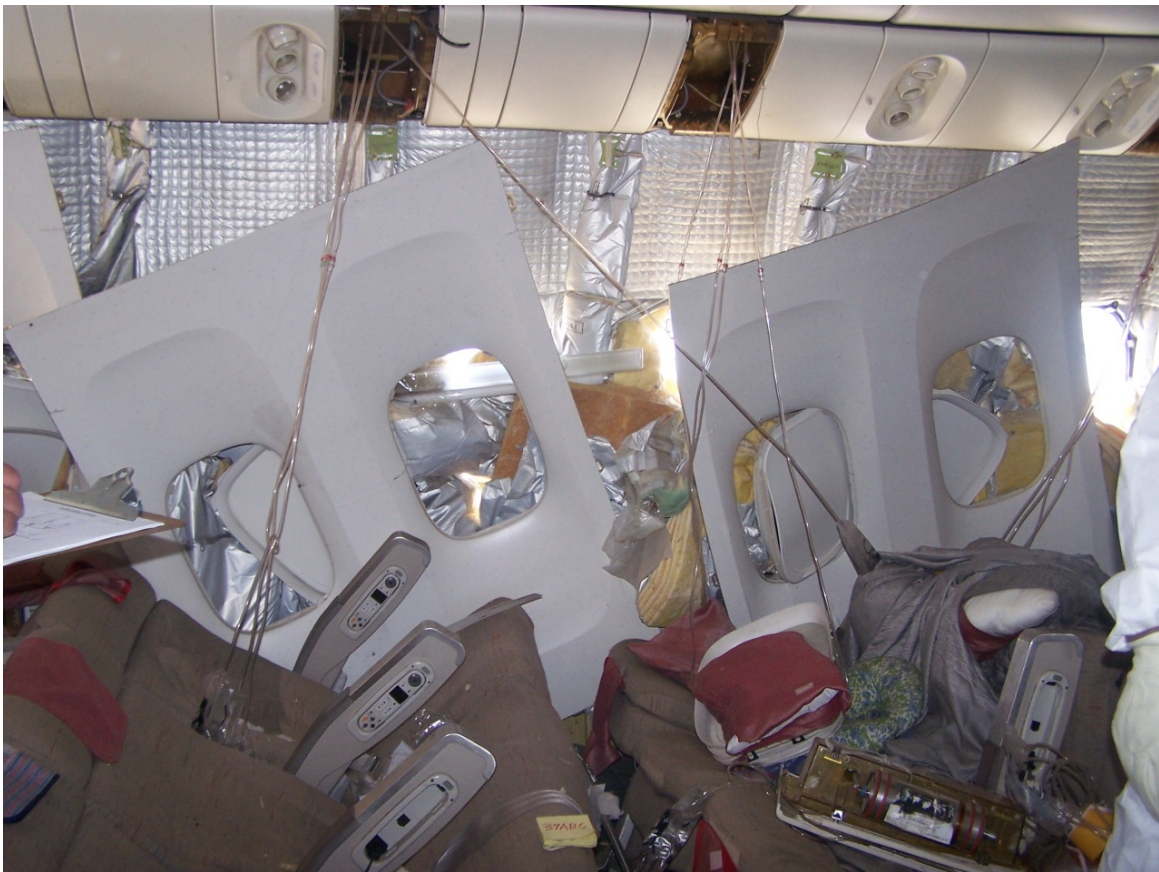
Photo 98. C-zone seats 37 ABC.

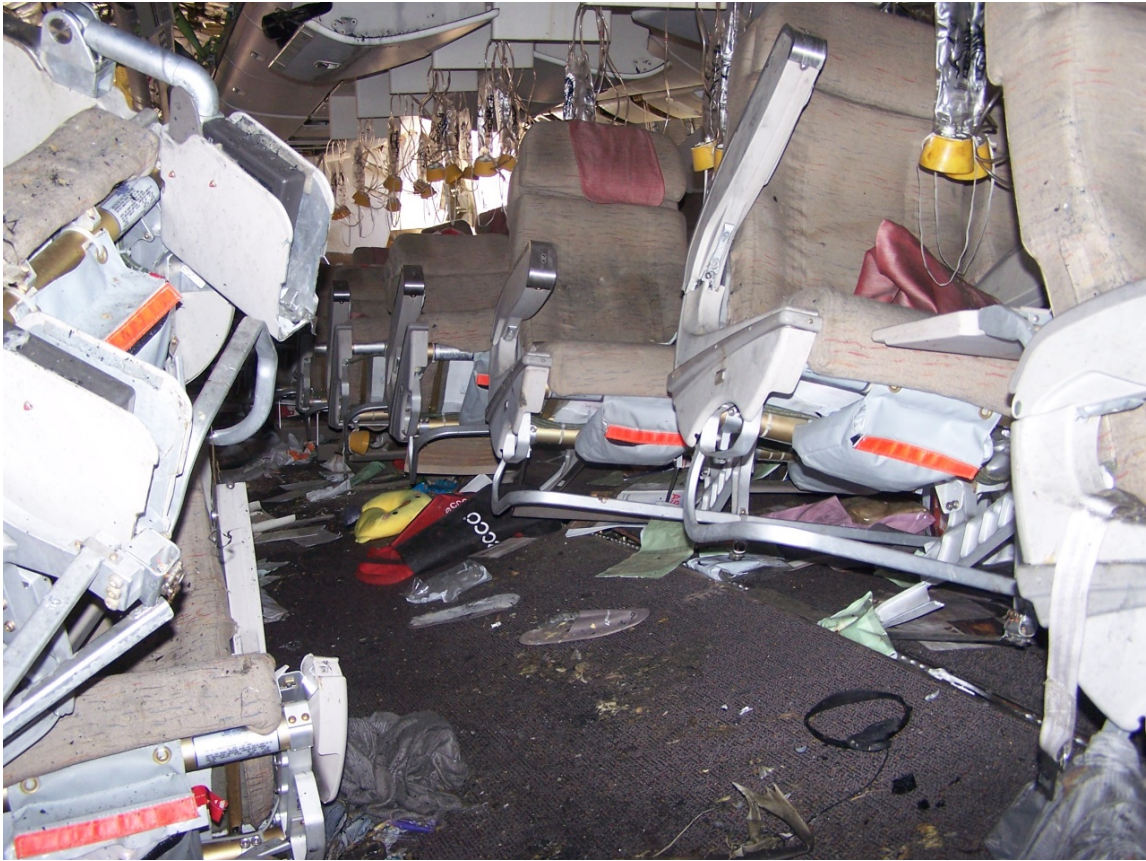
Photo 99. Aft-facing view of C-zone from left aisle near row 30.

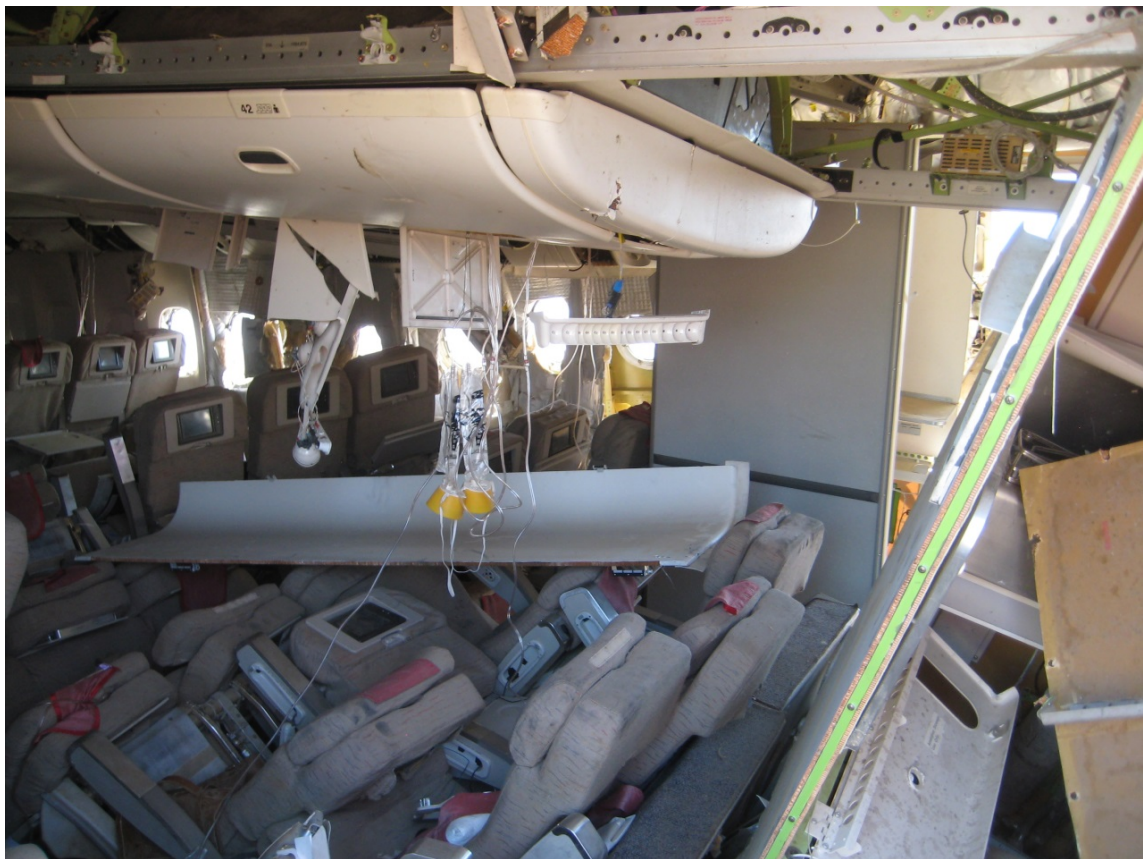
Photo 100. C-zone center seats, rows 41-42.

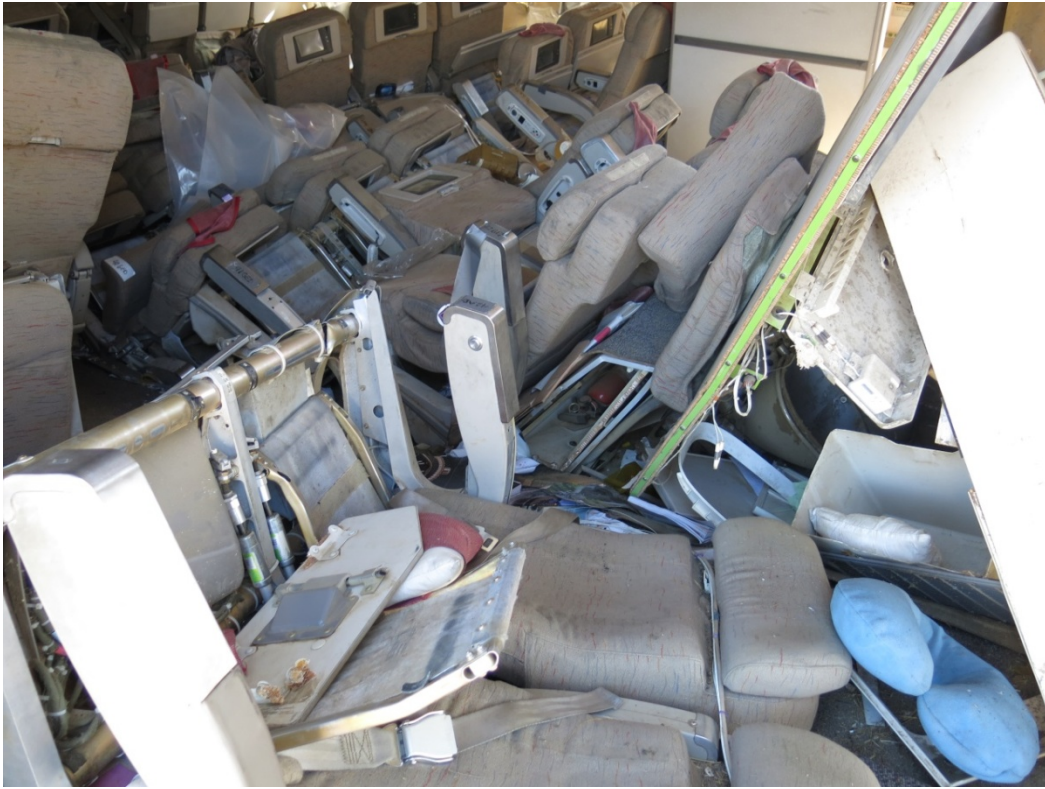
Photo 101. C-zone seat row 42.

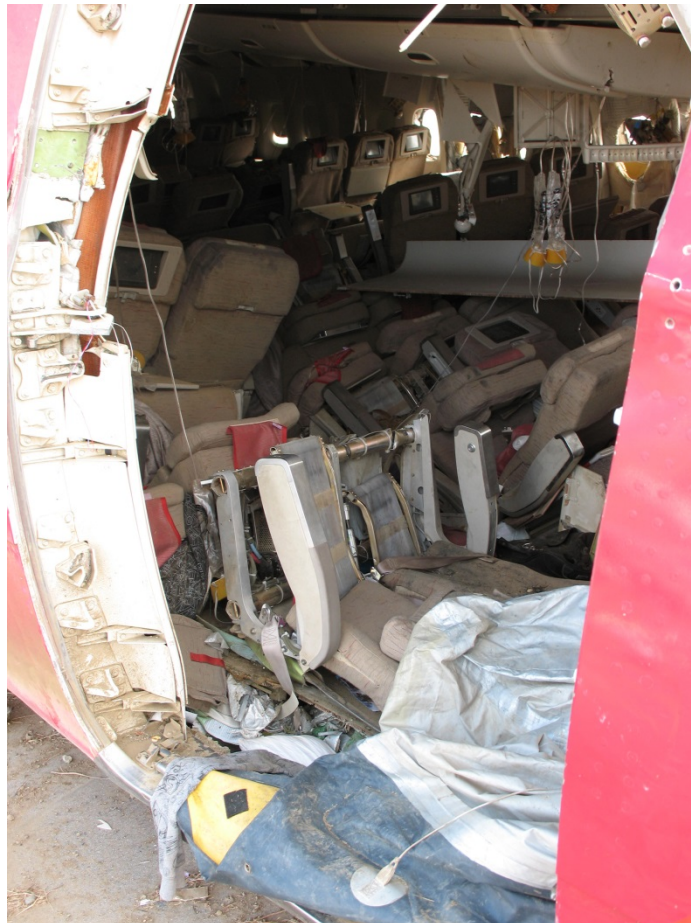
Photo 102. Seats 42A and B inside door 4L.

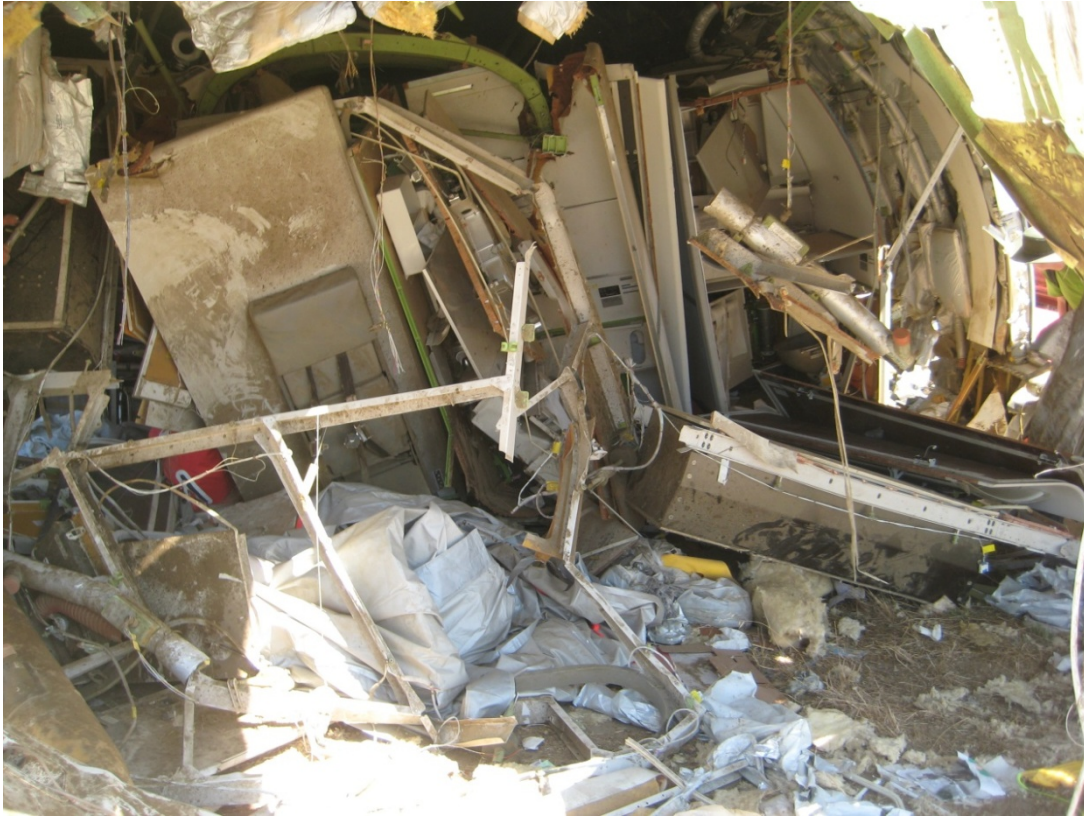
Photo 103. Forward-facing view of the aft of the airplane.
